*NIST Special Publication 862*

# 1994 Northridge Earthquake

## Performance of Structures, Lifelines, and Fire Protection Systems

*Diana Todd, Nicholas Carino, Riley M. Chung, H. S. Lew, Andrew W. Taylor,  
William D. Walton, James D. Cooper, and Roland Nimis*

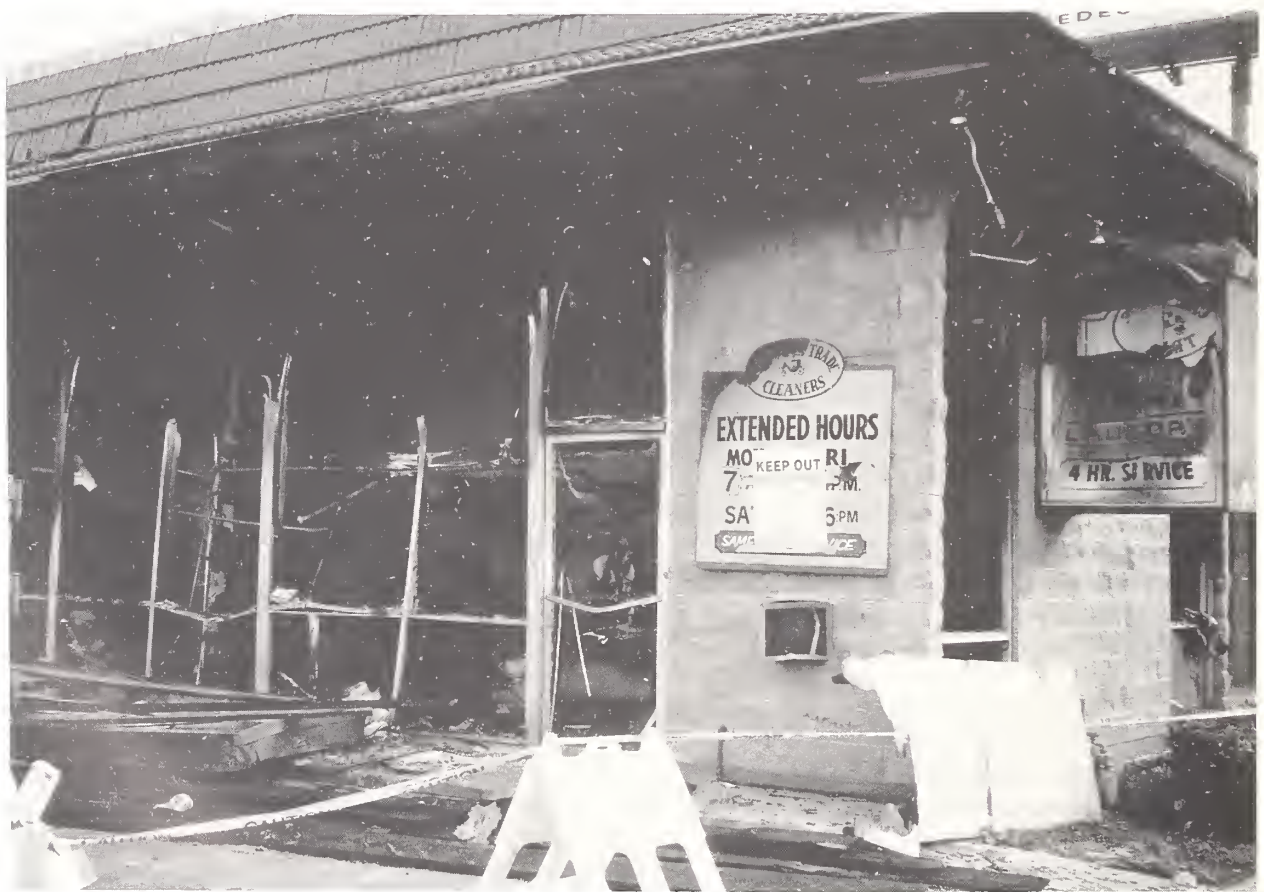
Figure 6.1. Fire damage in a single story commercial building.

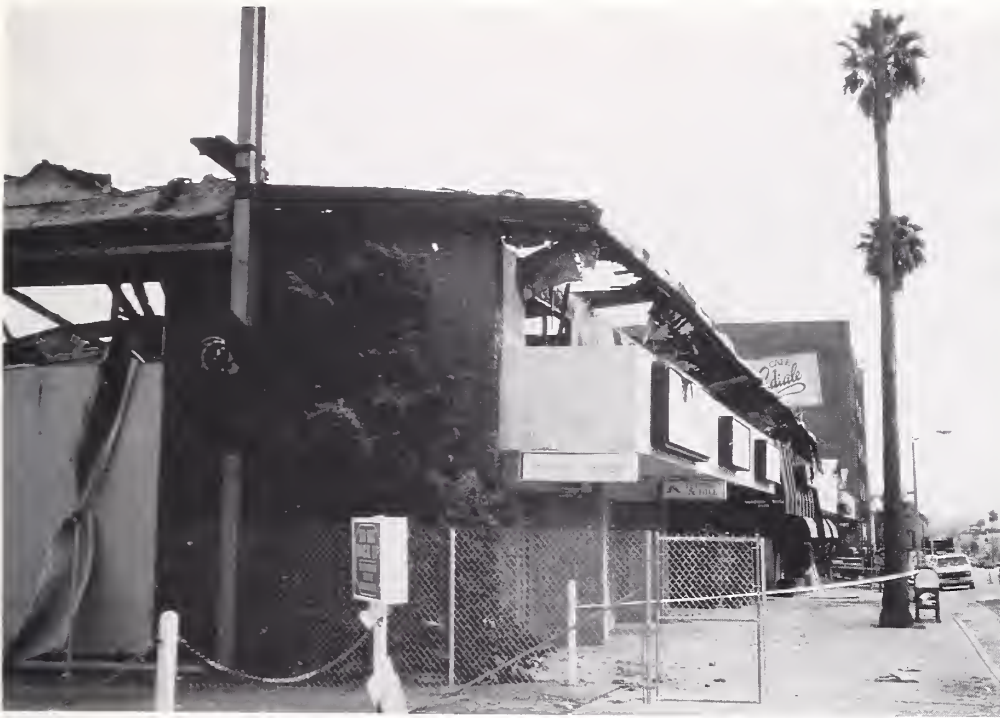
Figure 6.2. Fire damage in a two story commercial building.

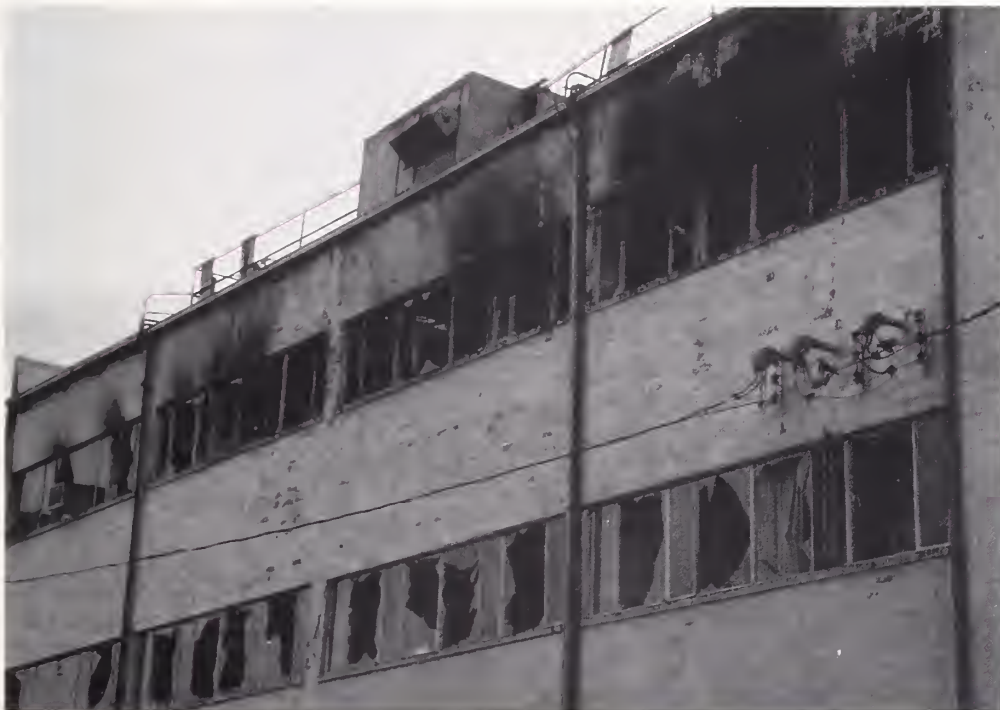
Figure 6.3. Fire damage in a three story commercial building.

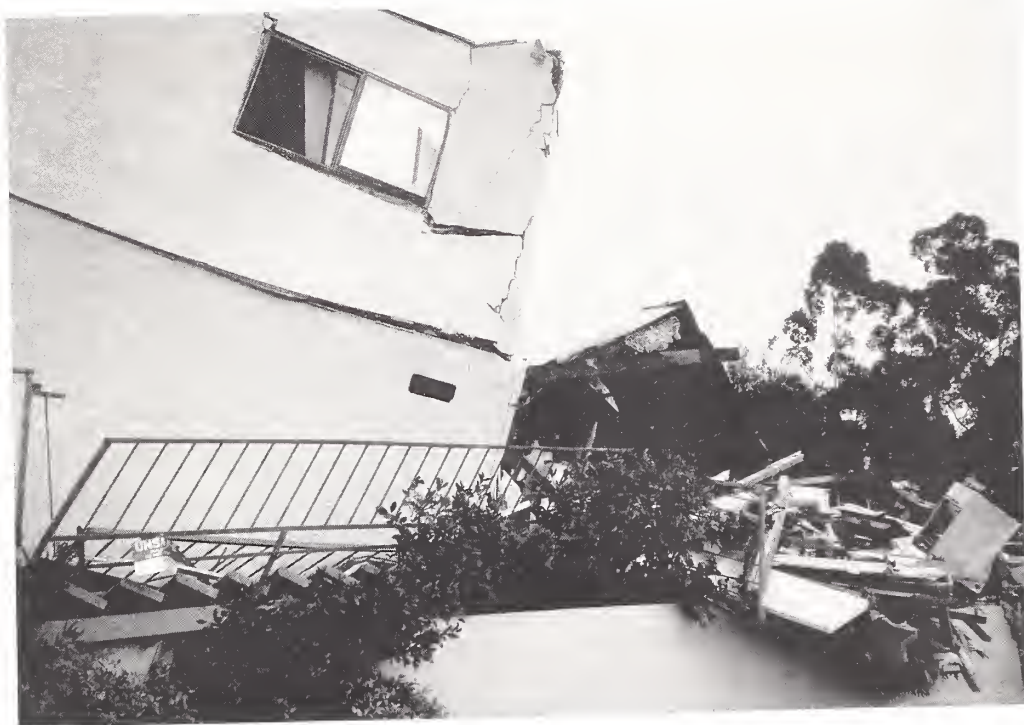
Figure 6.4. Partially collapsed apartment building with fire damage in the rear.

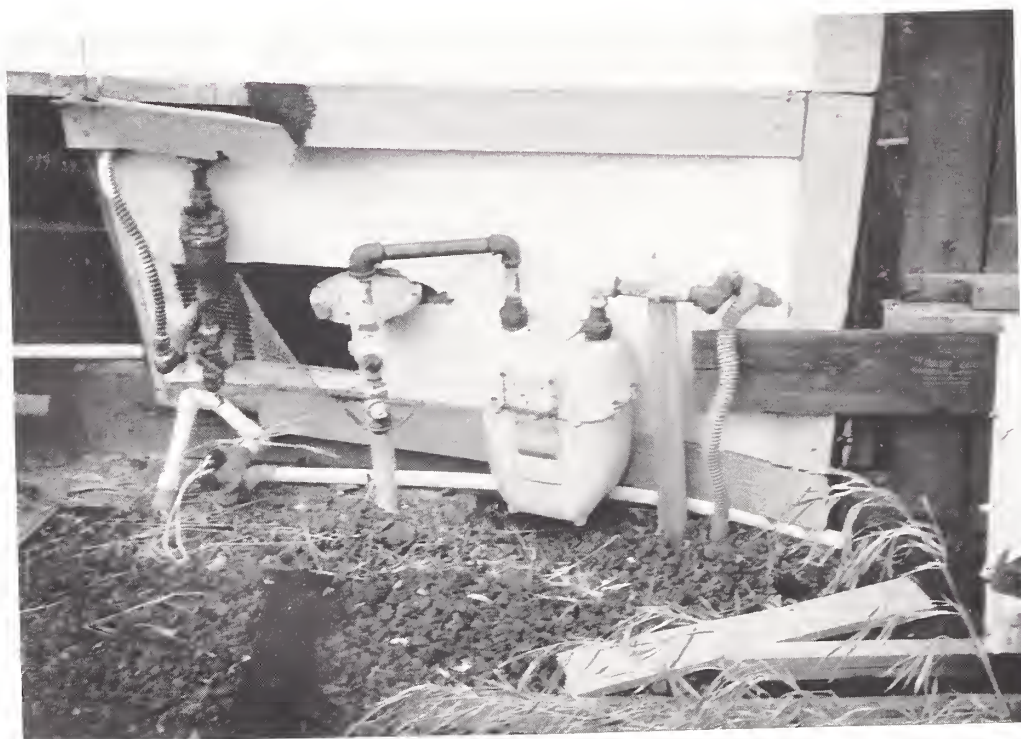
Figure 6.5. Damaged gas service in a manufactured housing development.

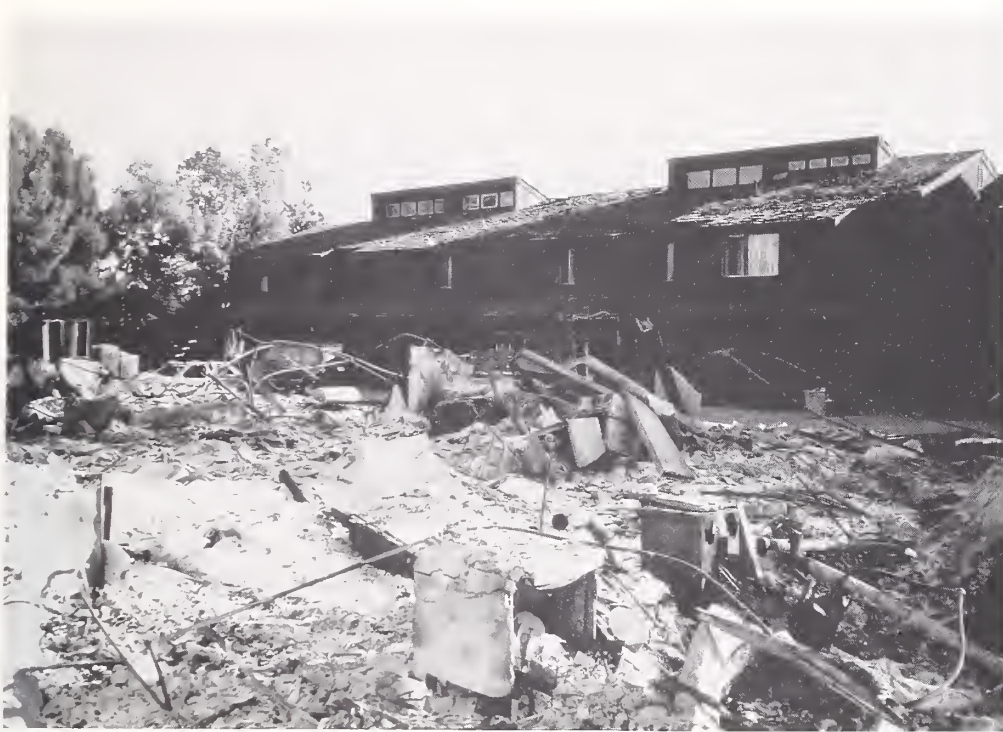
Figure 6.6. Multi-family residential building destroyed by fire.

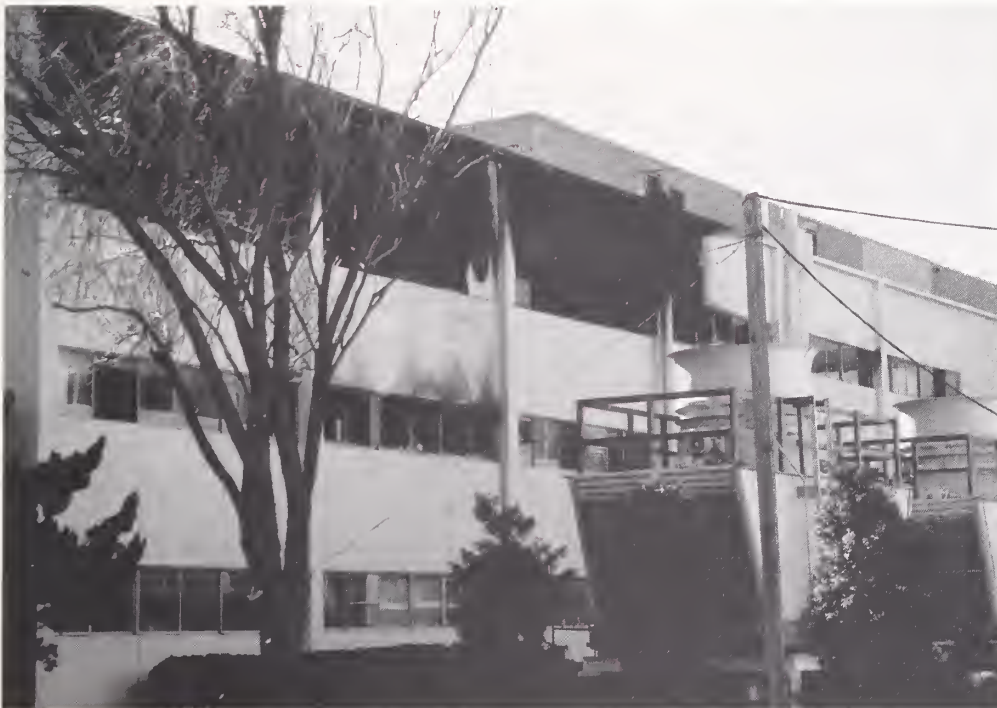
Figure 6.7. University science building damaged by fire.
